POLREP

The MORECO-Pierce Waste Oil Services Site is an inactive waste oil recycling facility located at 1925 East Madison Street. The site is situated on approximately 4 acres of land in an industrial and residential area on the Northeast side of Springfield. The property is surrounded by a chain link fence with locked gates, but sections of the fence are missing. The site is bordered by Sangomo Construction Co. property on the north, by the Illinois Central Gulf Railroad (ICGR), Capital City Ready Mix, and Contractor City Lumber on the east, and the ICGR and open areas to the west and south. Residential areas are located 700 feet west of the site (see attached site map).

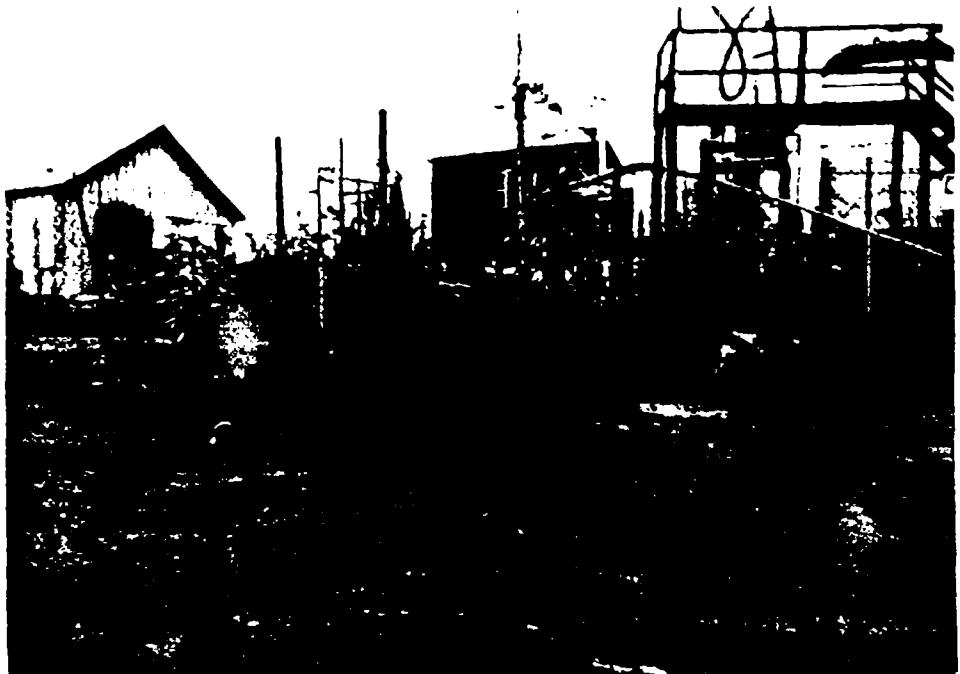
SAMPLE ID
(if applicable):
OS102

DESCRIPTION: Perspective view of sample OS102 collected just south
of the containment area which had overflowed.

-Obtain and review analytical results from Blank Laboratories for the four samples collected from areas affected by the release. Determine if the soil contamination poses a threat and requires removal.
